Technical Report M-357  
September 1984

Improved and New Roofing  
for Military Construction

**FIELD TEST RESULTS OF EXPERIMENTAL EPDM  
AND PUF ROOFING**

by  
Myer J. Rosenfield

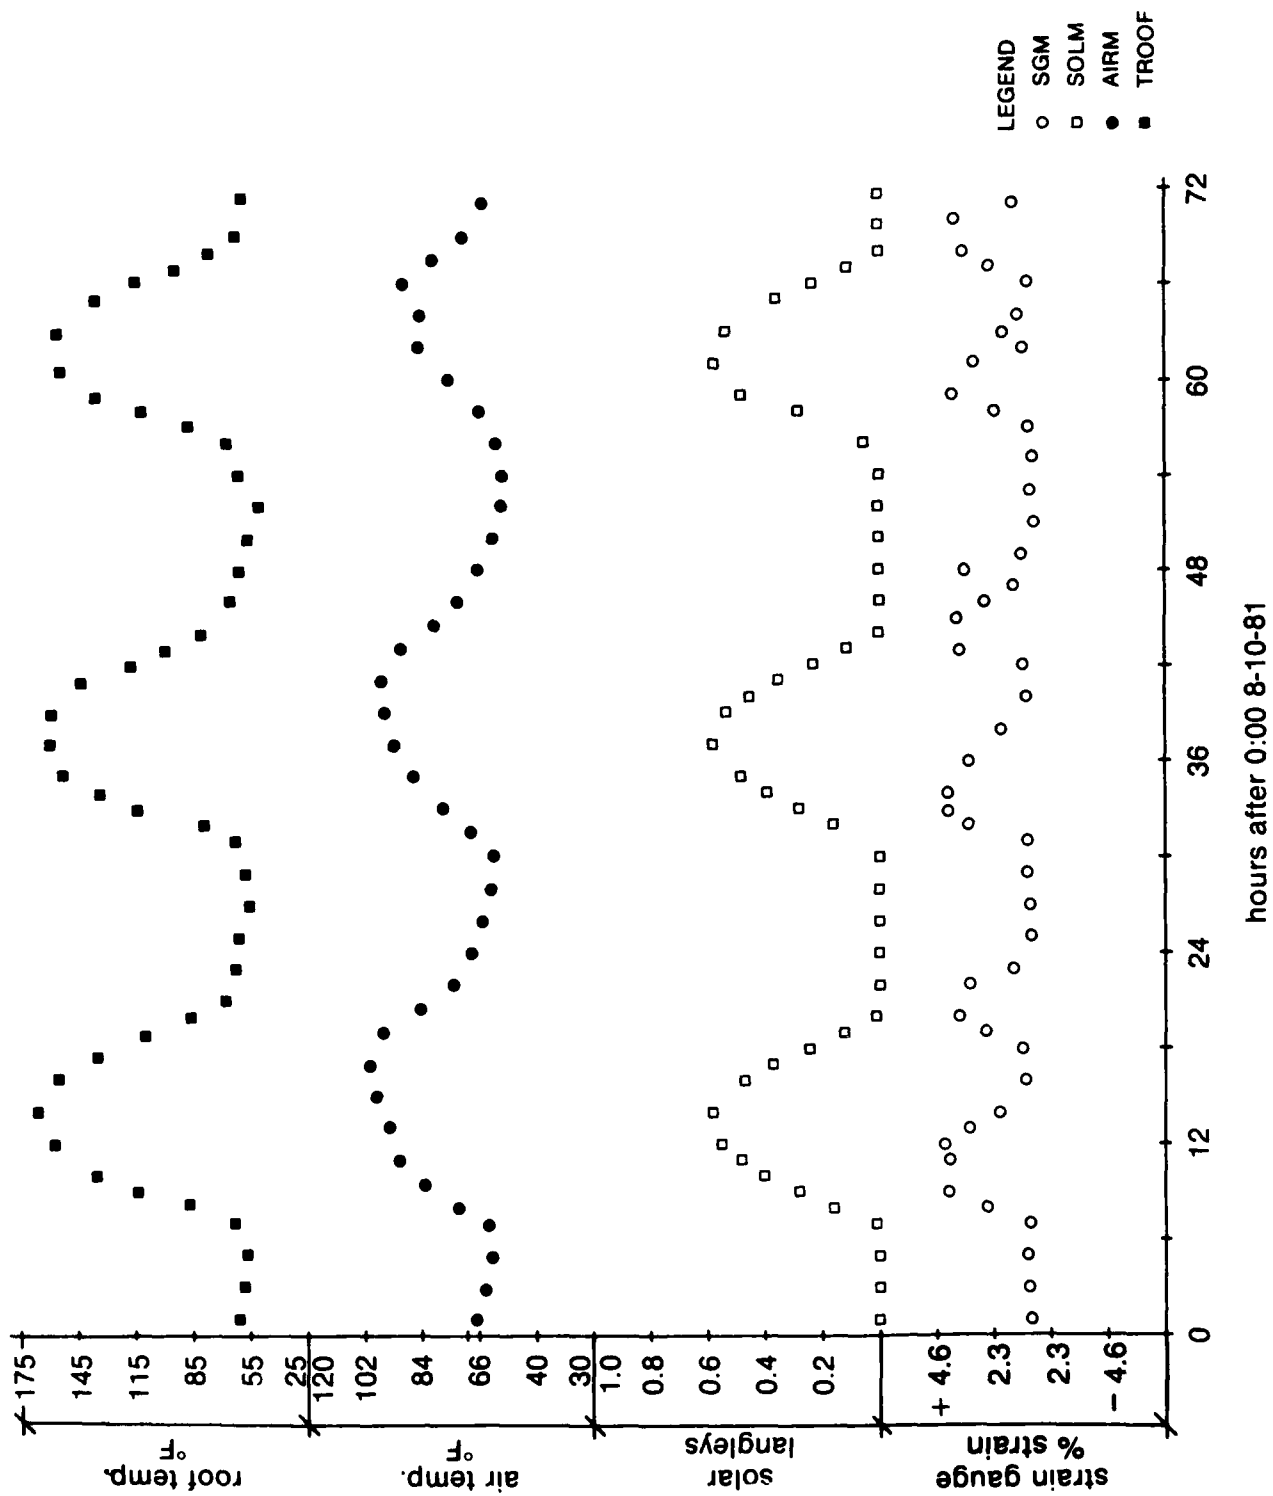
Figure 40. Parameters vs. time, high temperature and high sun - Fort Lewis, August 10-12, 1981.

The plots clearly show the strong relationship between solar incidence and strain gage response. The plots with low solar incidence show virtually no change in percent strain, while those with high solar incidence show an almost immediate response to solar incidence. The double peak condition at Fort Lewis is very obvious in Figures 40 and 42.
